RE: Site Inspection, Quality Building Stone, Amis #1 Quarry, Unpermitted Site S/049/038, Utah County, Utah

Date of Inspection: September 26, 2002, and October 18, 2002

Quality Building Stone, Amis #1 Quarry (Unpermitted)

S/049/038

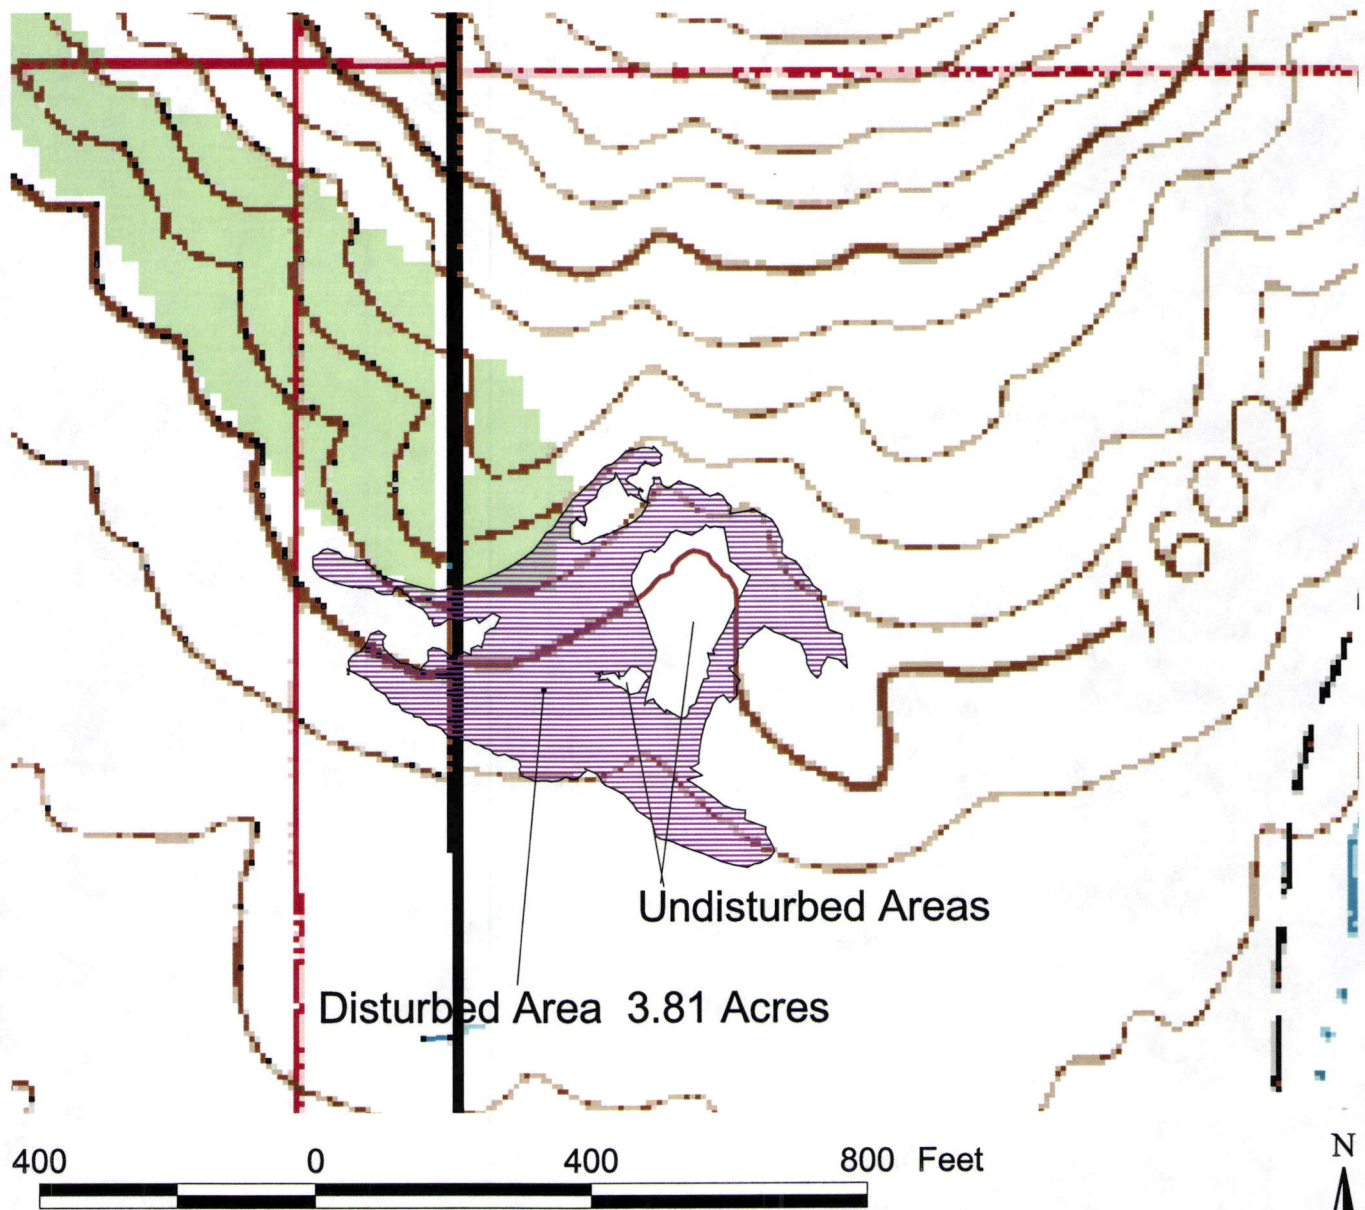
# Wes Hansen, Quality Building Stone Quarry in Emma Park

The attached map shows the location and shape of the site. According to Mr. Hansen, the area was previously disturbed, and some of the pad outcrops have oaks and grasses that have been growing there for many years. I was careful to not include these in the measurement of the disturbed area. There were some undisturbed areas within the larger disturbed area.

Map created October 21, 2002, from data collected October 18, 2002, by Paul Baker. Matts Summit (east) and Kyune (west) quadrangles. Disturbed area is in Township 11 S., Range 9 E., Section 36, SLBM.

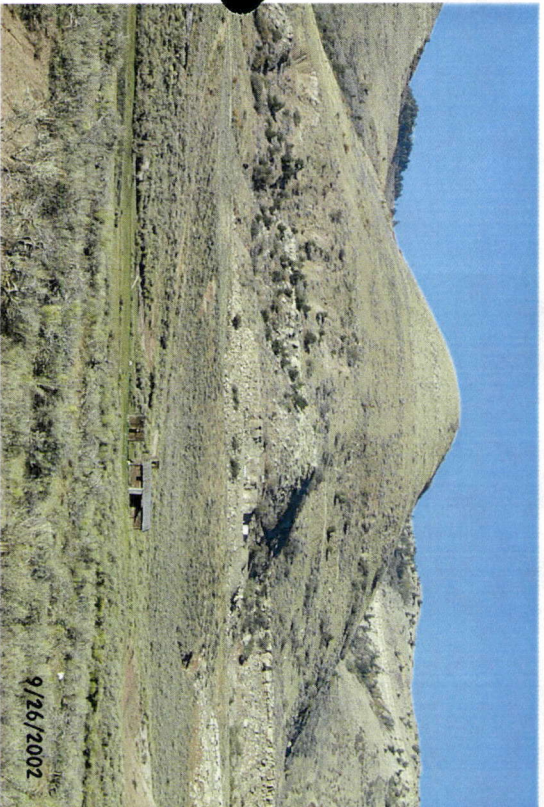
Starting on U. S. Highway 6 at the top of Price Canyon, go 3.7 miles on the Emma Park road toward U. S. 191 (Indian Canyon). On the north side of the road, there is a gated turnoff leading north, east, then north again toward the quarry. There are a few forks in the road, but it is not hard to see the quarry on the hill and head toward it (Photo 1). It is about 1.5 miles from the Emma Park road to the quarry.

Photo 1. Quarry is near the center of the photo.

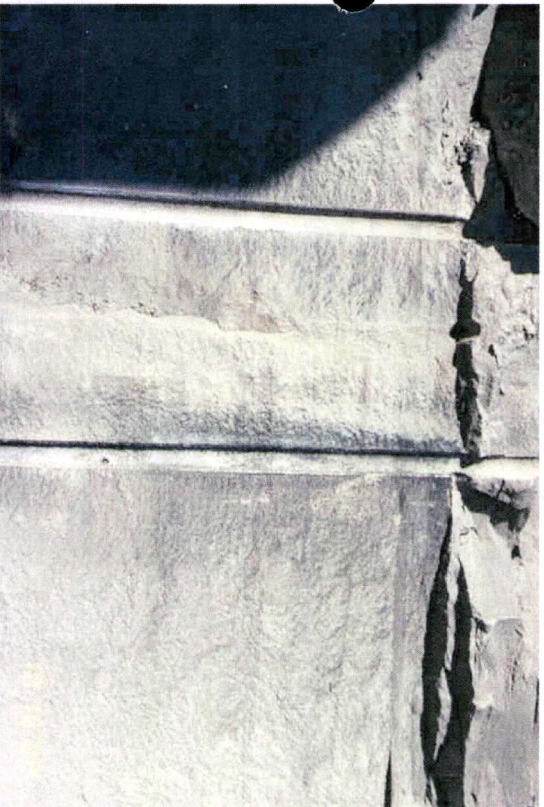
The operator is quarrying sandstone both from the surface and from the consolidated bedrock. It appears the surface rock is dragged to where it can be split into desired sizes. The operator drills the bedrock deposit and, according to Mr. Hansen, uses gunpowder to break off large pieces. These blocks are then split further as needed. I was able to see the drill holes in the rock and darkened areas where gunpowder was apparently used (Photo 2).

Photo 2. Drill holes and discolored areas (from gunpowder?) in the bedrock.

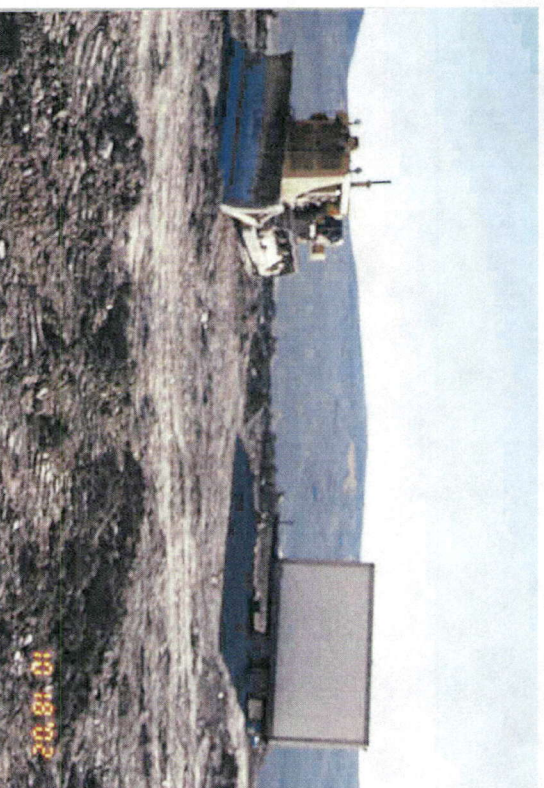
Equipment on the site included a white trailer (not a house trailer or recreational vehicle), a compressor, a small dozer, and a tracked front end loader. See Photos 3 and 4. There was some garbage lying around, including 55-gallon barrels and smaller containers for oil products.

Photo 3. Dozer and trailer.

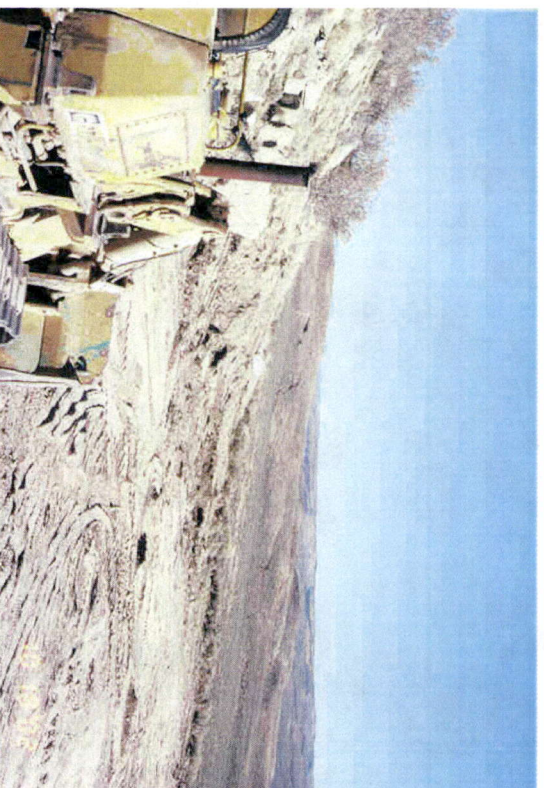
Photo 4. Front end loader near the east end of the disturbed area.

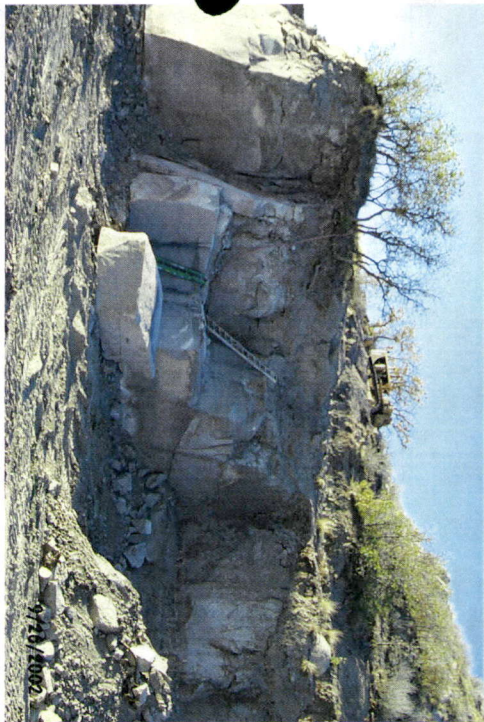
Vegetation in the area is dominated by Gambel's oak, Salina wild rye, and sagebrush, and most of the area has relatively thick soil with a lot of organic matter (Photo 5). The operator has not stockpiled any soil.

Photo 5. The bedrock sandstone that is being quarried. Note the amount of soil both above the rock and in the working area in the foreground.

The operator needs to begin salvaging topsoil. There are some areas where it could be stockpiled out of the way of the operations, and the operator has equipment on hand that could be used for this purpose.
